RESULTS OF FIELD TRIALS OF THE
TREE EATER
A TREE AND BRUSH MASTICATOR

U.S. DEPARTMENT of AGRICULTURE
FOREST SERVICE
EQUIPMENT DEVELOPMENT CENTER
SAN DIMAS, CALIFORNIA

ED&T 1222 //

U.S. Department of Agriculture, Forest Service
Equipment Development Center, San Dimas, California 91773
January 1970

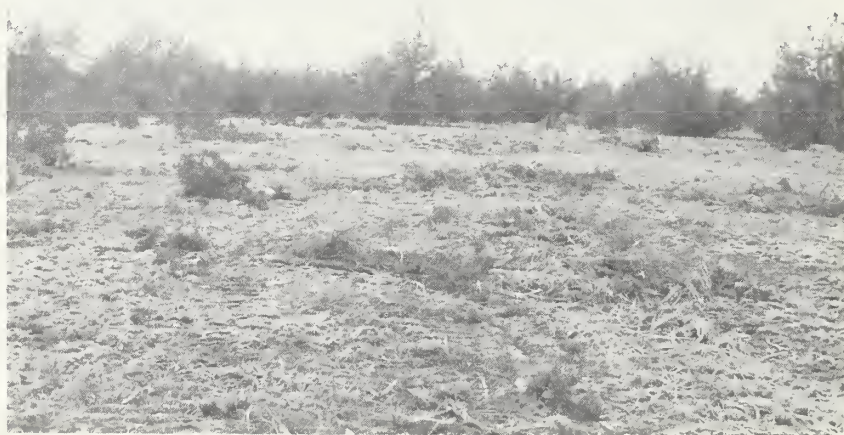
In some cases it is desirable to leave larger trees to increase clearing production, provide shade and an aesthetically pleasing appearance, and to reduce costs. This will be covered in more detail later in the report, under Production Performance. Figure 6 shows an area cleared of standing junipers. The machine achieved nearly total mastication; but, because the cutters were not set at near-ground level, all of the lateral branches at the bases of the stumps were not removed.

Figure 6. Standing juniper plot after test

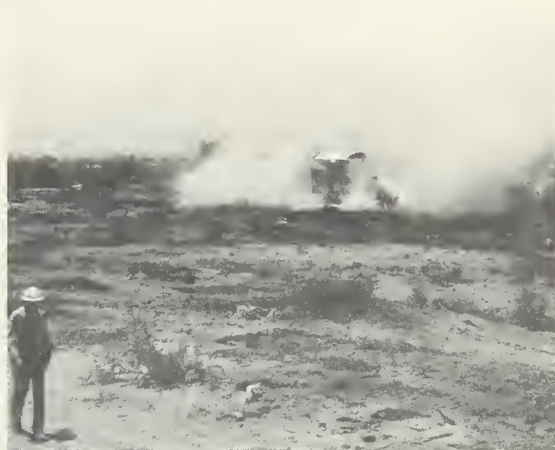
Figure 8. Cutover area - note scattered cholla joints

All parts of the cholla cactus engaged by the cutters were ground to a green pulp. But, since propagation of this plant is primarily by regrowth of joints setting roots in the ground, those parts that escape the cutter and are not completely destroyed could become re-established.

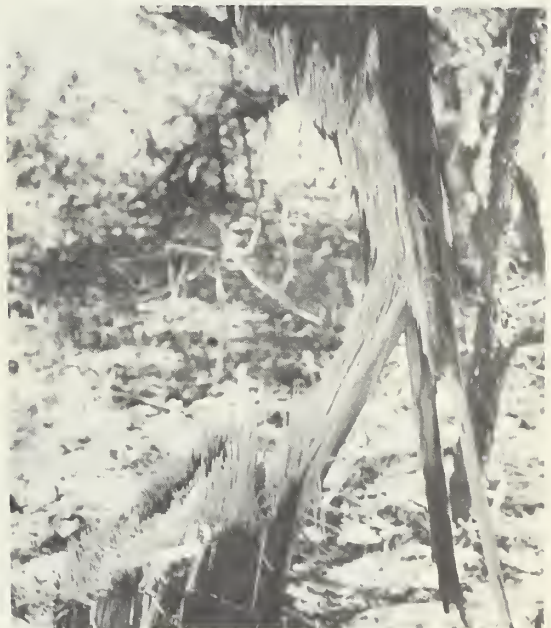
Figure 11. Effects of flail cutters on 18-inch tree

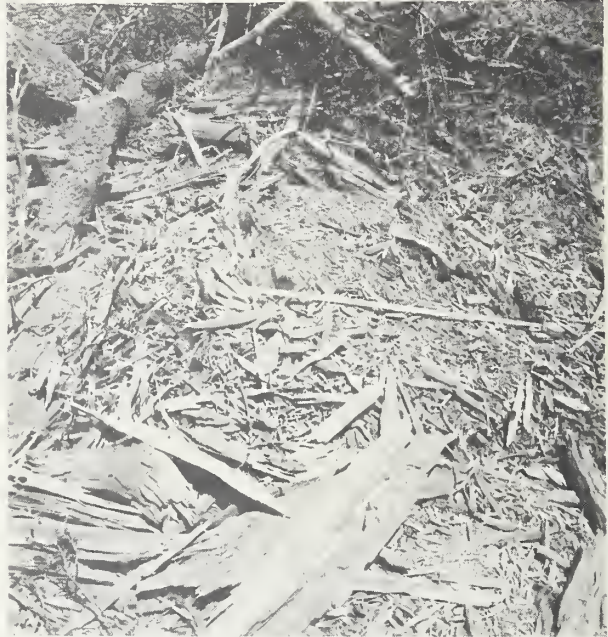
Figure 13. Coarse debris from a shattered alligator juniper
